Manhole Inspection Summary

Manhole # S37AA1025MH

Insp Date: **1/3/07 10:22 AM**

Location Address: **3307 frisby st**

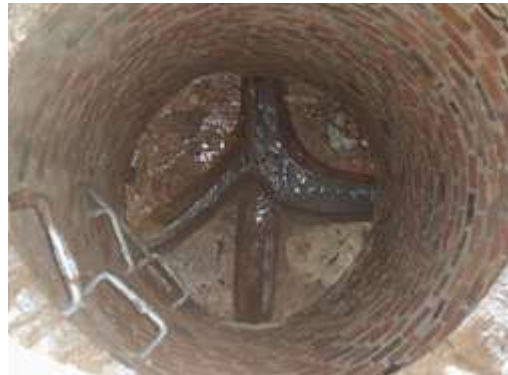
Top View

Frame leaks. Adjustment infiltration.
Corroded steps. Evidence of surcharge -
Bench debris. Channel debris.

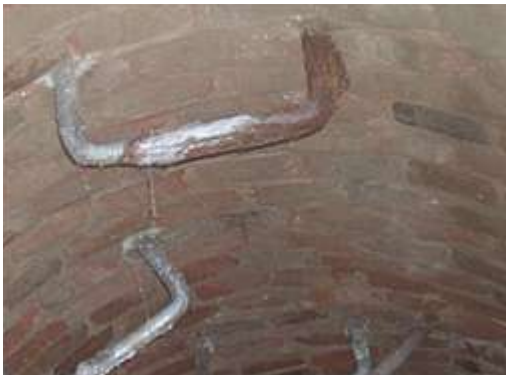
Defect

Barrel infiltration.

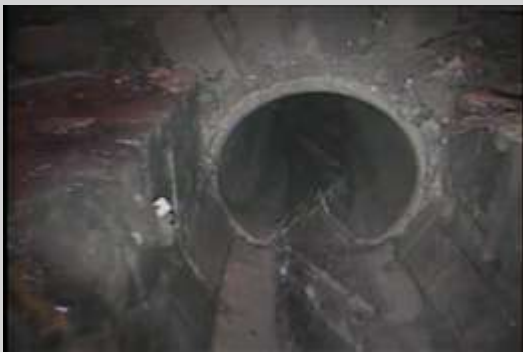
8 in. Circular Gravity Sewer Pipe Out @ 12 O'Clock

Invert Depth: **9.56** (ft.) Flow Characteristics: **Slow**

Deposits: ☒ None ☐ Mud ☐ Sludge ☐ Debris ☐ Grease

Infiltration: **None** Pipe Seal Cond: **Unknown**

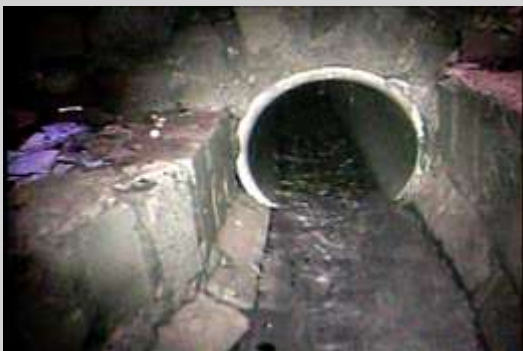
8 in. Circular Gravity Sewer Pipe In @ 3 O'Clock

Invert Depth: **9.35** (ft.) Flow Characteristics: **Slow**

Deposits: ☒ None ☐ Mud ☐ Sludge ☐ Debris ☐ Grease

Infiltration: **None** Pipe Seal Cond: **Unknown**

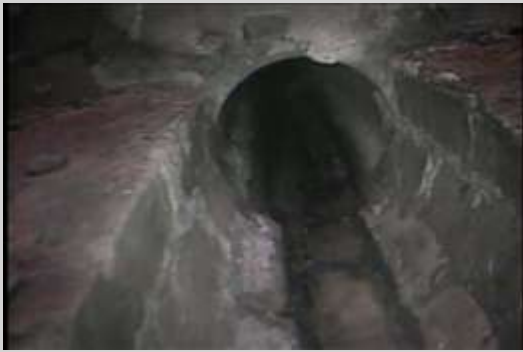
Pipe In @ 6 O'Clock

Invert Depth: **9.32** (ft.) Flow Characteristics: **Slow**

Deposits: ☒ None ☐ Mud ☐ Sludge ☐ Debris ☐ Grease

Infiltration: **None** Pipe Seal Cond: **Unknown**

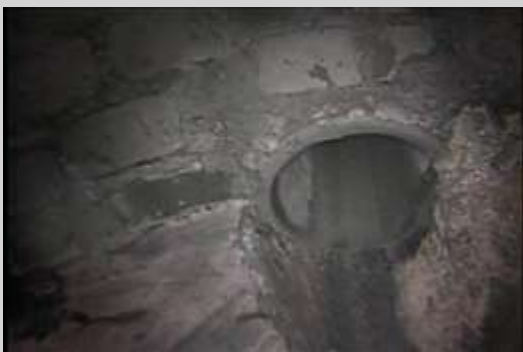
Pipe In @ 8 O'Clock

Invert Depth: **8.76** (ft.) Flow Characteristics: **Slow**

Deposits: ☒ None ☐ Mud ☐ Sludge ☐ Debris ☐ Grease

Infiltration: **None** Pipe Seal Cond: **Unknown**
